Cherry Hinton and Coldham's Brooks: A Portrait of a Much-abused Suburban Chalk Stream

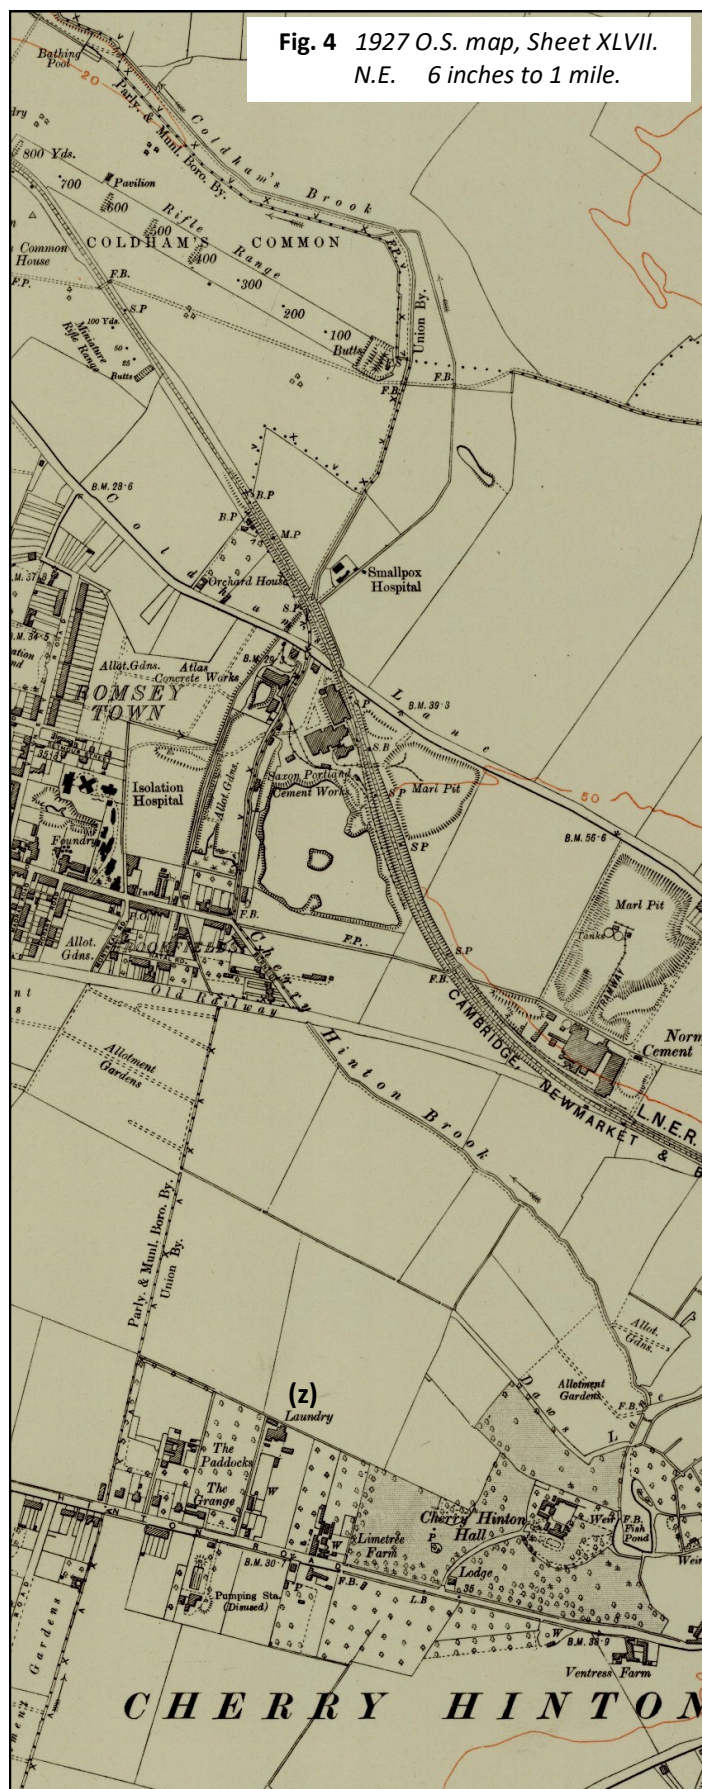
Fig. 4 1927 O.S. map, Sheet XLVII.
N.E. 6 inches to 1 mile.

the leat (at (d)). Modern (hillshade)LIDAR maps show no clear traces of earlier meanders.

At the time of writing there is still a widespread belief that the abandoned 16th century Paper Mills Leat (Map 6) is a brook (i.e. Coldham's Brook) and not a leat. (as in Fig. 4, for example.)

Just as the courses of the drains are straight and angular, the Cherry Hinton Brook also turns through an artificially-created angle at the footbridge (F.B.) where The Tins footpath (F.P.) meets Burnside. There is no convincing alignment in Fig. 4 or on the ground) to correspond with link 'y' in Fig. 3.

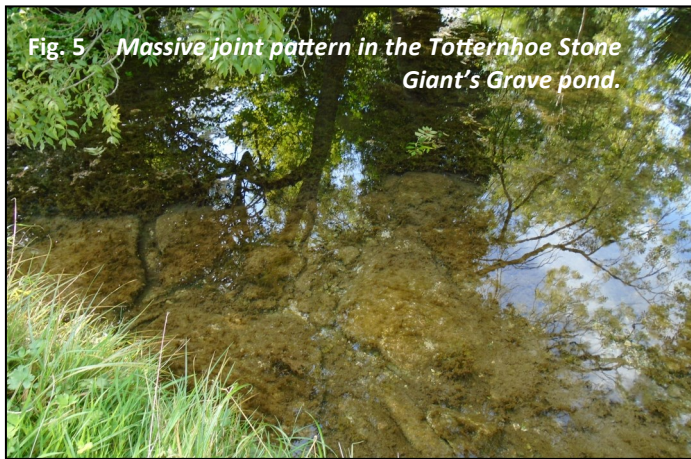
Fig. 5 *Massive joint pattern in the Totternhoe Stone Giant's Grave pond.*

However, to begin again at the beginning: the Giant's Grave pond (Figs. 13 and 15) is fed by Chalk springs. Water emerges through joints in the Totternhoe Stone (Fig. 1, a hard grey silty calcareous sand) where it overlies the Marly Chalk Formation. The massive (widely spaced) pattern of joints can be seen in the bed of the pond (Fig.5). So, after leaving the pond, the brook has some of the features characteristic of 'Chalk streams'. For example crystal clear water flowing over flint gravel can be observed from the bridge in Forest Road (at A in Fig.13) though the gravel is not 'natural' being so near to man-made constructions.

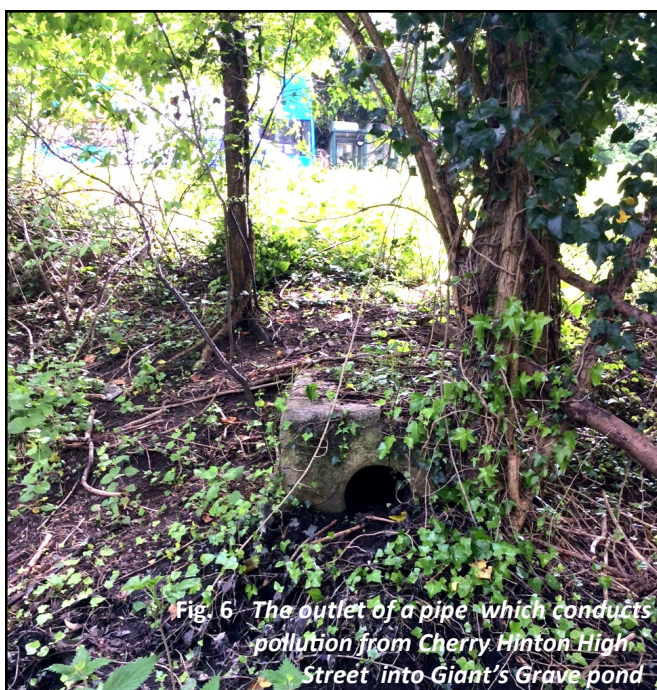
Fig. 6 *The outlet of a pipe which conducts pollution from Cherry Hinton High Street into Giant's Grave pond*

Measurements were taken at the 6 points shown in the OS map on the right. They were taken during dry weather flow conditions which showed the brook in the best circumstances, qualifying as ‘High Quality’ under the Water Framework Directive parameters. However, following rainfall it is most likely that there would be a deterioration in water quality due to urban run-off (e.g. Fig. 6).

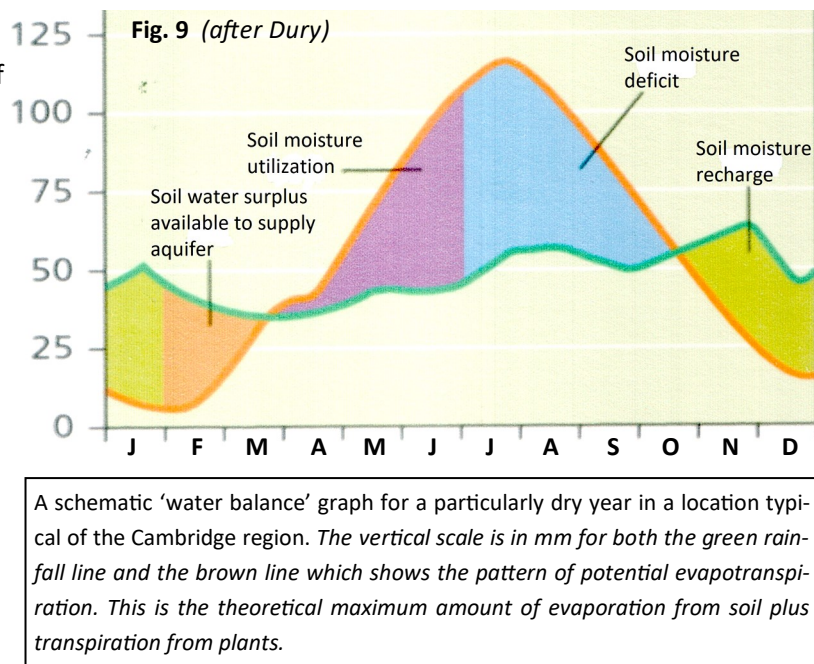
Cambridgeshire Chalk streams are so fundamentally vulnerable to over-abstraction or a shortage of rain are explained in Fig. 9. Rainfall in East Anglia is so low and summer evapotranspiration is potentially so high that, often, depending on local conditions and the weather, soil moisture and aquifer recharge only occur between October and March when, in relation to rainfall, temperatures and potential evapotranspiration are at their lowest. In general terms soil moisture has to become saturated before the water infiltrates down to the water table.

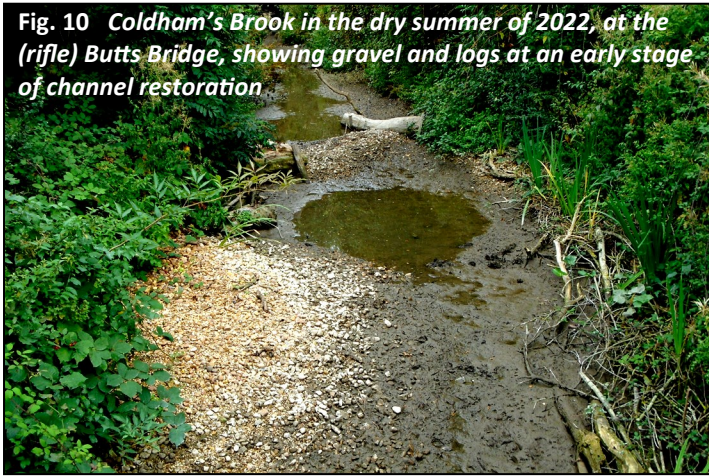
Fig. 10 Coldham's Brook in the dry summer of 2022, at the (rifle) Butts Bridge, showing gravel and logs at an early stage of channel restoration

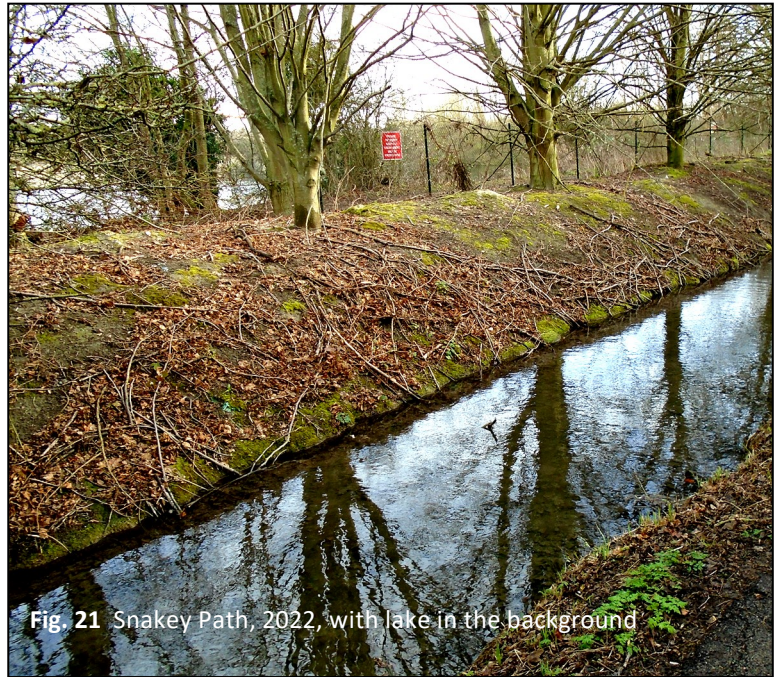
Fig. 21 Snakey Path, 2022, with lake in the background

The lakes beside the brook (background of Fig. 21), excavated in the Marly Chalk for the cement works, are, of course, an abuse of landscape on an industrial scale in themselves. Before the cement works closed the disposal of waste into the brook caused it to flow sludgy grey and must have contributed to the deposition of silt on the bed of the channel.

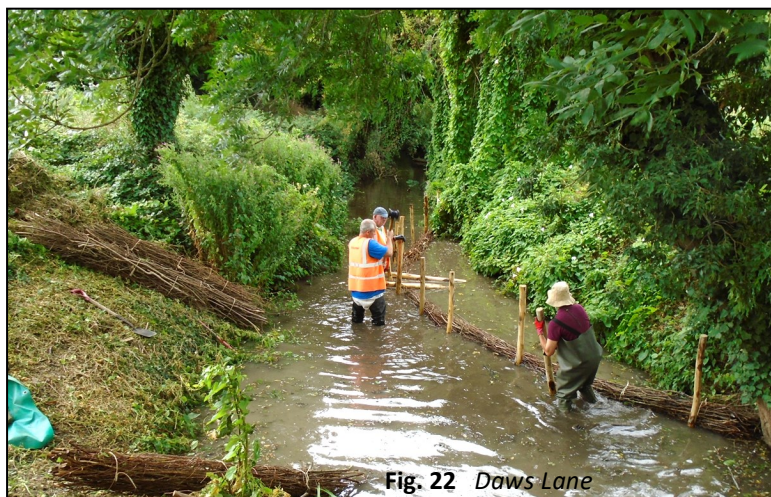
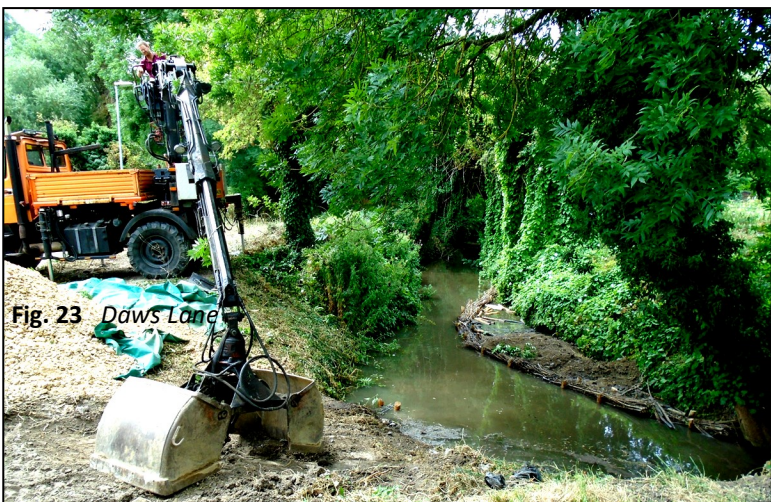
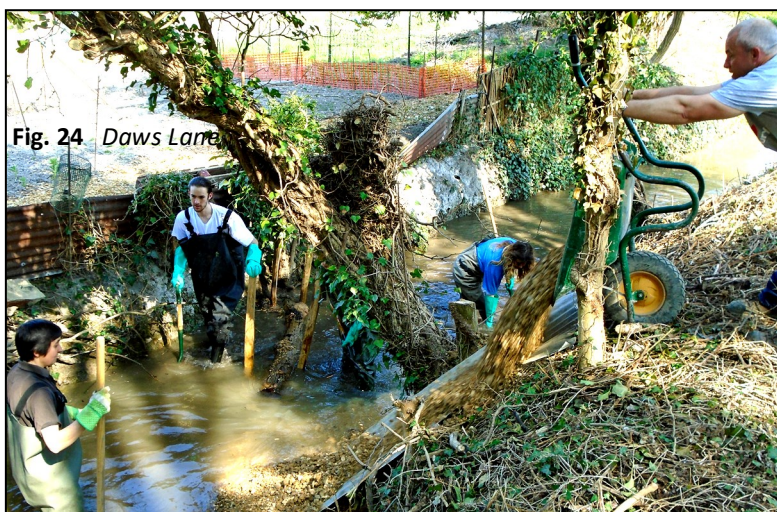
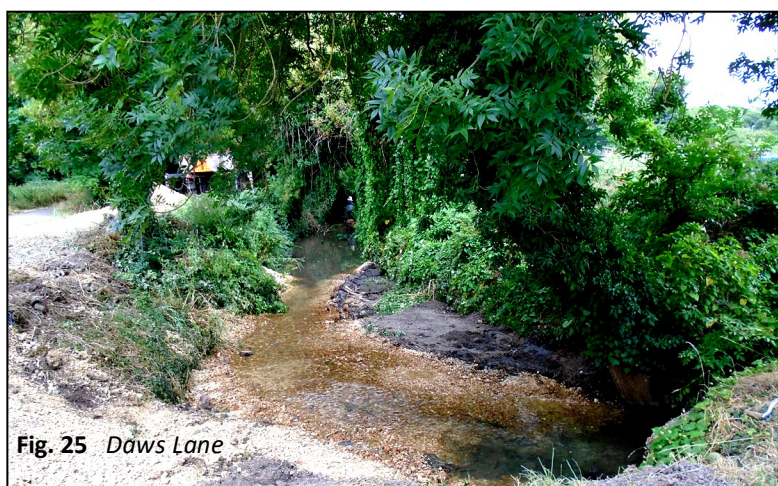
The simple channel restoration undertaken in the two brooks can be seen as the construction of channels within a channels. The photographs in Figs. 22-25 were taken alongside the Blacklands allotments, Daws Lane. Brushwood fascines were staked in the channel to make it narrower (Fig. 22) and more naturally sinuous thus increasing the rate of flow and helping to flush out silt. Fascines are often made on the spot using bankside branches cleared to open the channel to more light to encourage, for example, colonisation by water voles. Logs, staked in position Fig. 26) are used as flow-

Unfortunately, although gravel has now been laid in the channel from the pond in the grounds of Cherry Hinton Hall to the allotments bridge in the bottom right-hand corner of Fig. 25, twenty or thirty tons of gravel delivered by lorry covers very few yards of channel. Furthermore, downstream, gravel has only been applied at conveniently accessible points such as at the upstream end of Burnside and at St. Bedes Crescent (Fig. 26). Unhappily, some of the flow deflectors and gravel at these locations have sunk out of sight into the underlying silt. The stretch beside Sainsbury's (Fig. 27) was more successful. Here, silt was sent downstream by vigorous trampling before the gravel was laid.

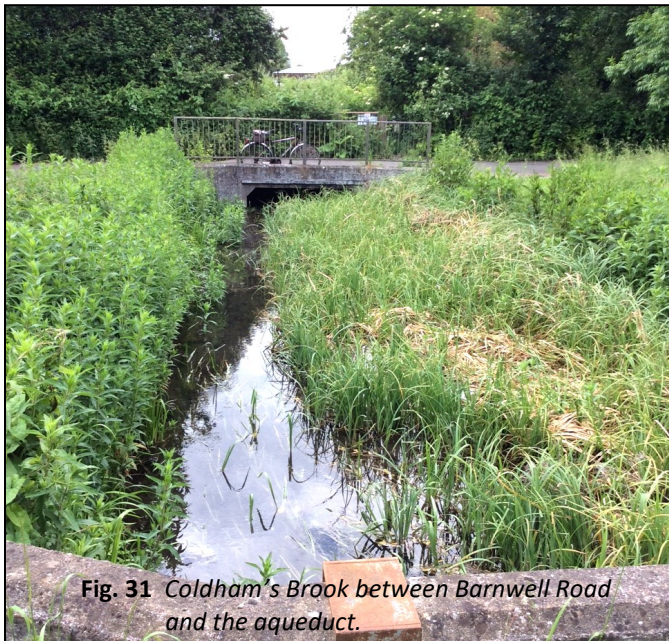
Fig. 31 Coldham's Brook between Barnwell Road and the aqueduct.

The photograph in Fig. 31 was taken from K in Fig. 30 where the Coldham's Brook emerges from under the Barnwell Road. The photograph of the Main Drain in Fig. 32 was taken from B in Fig. 30 looking upstream towards the aqueduct. Though the pipes on the left are blocked, there are scores of similar pipes which are actively discharging pollution into the drainage system, both artificial and 'natural' (see Fig. 6).

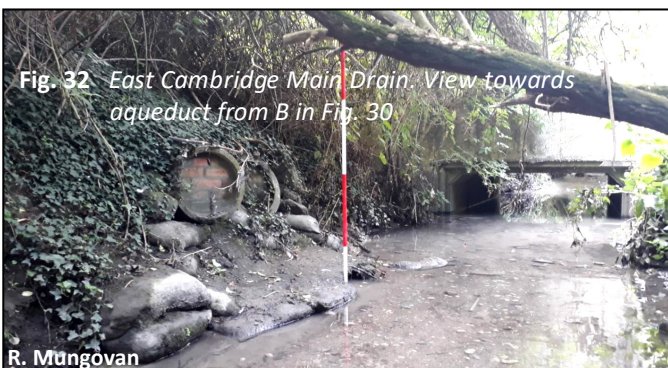
Fig. 32 East Cambridge Main Drain. View towards aqueduct from B in Fig. 30

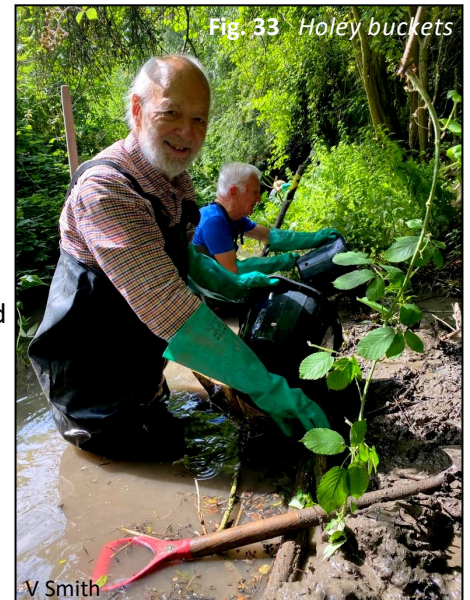
Fig. 33 Holey buckets

Because of the difficulty of carrying gravel, restoration without gravel has concentrated on narrowing the channel with transverse logs and marginal brushwood or fascines staked in position. Fig. 33 shows holey buckets being used to scoop up silt from the bed of the channel and poured into brushwood.

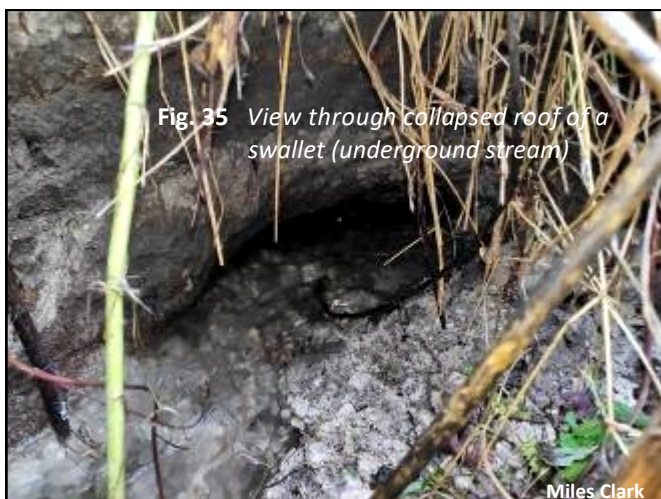
Here, in 2024, [what3words location: care sugars neck] there was an underground stream or swallet (Fig. 35) which ran directly from the bank or bed of the channel, under a concrete wall at a depth of about 2 feet, then some 10 yards down into the Main Drain. The collapsed roof of the swallet revealed the abundant free flow of water throughout 2024. In 2025 it was plugged with imported clay.

Where the brook crosses the Main Drain at (c) the altitude difference mentioned above is maintained or, more likely, increased. Between (c) and (d) the leakage from the brook down through the lowest strata of the West Melbury Marly Chalk Formation and laterally into the Main Drain is most obvious as it approaches the aqueduct at (d) near Galfrid Road (Fig. 35 and Map 6).

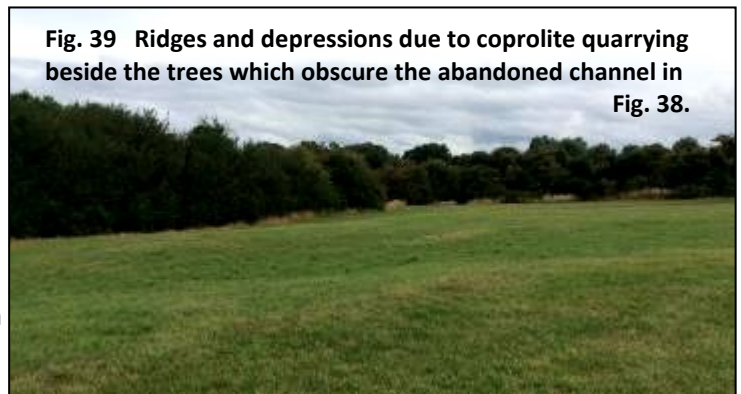
Fig. 39 Ridges and depressions due to coprolite quarrying beside the trees which obscure the abandoned channel in Fig. 38.

the Gault and the Marly Chalk, lie at no great depth. These were the strata which contained phosphatic nodules (known as coprolites) which were of such great value to agriculture in the second half of the 19th century. The nodules were dug from trenches which were backfilled, leaving a series of ridges and depressions (Fig. 39). The Weigh House survives at 101 Coldham's Lane. The enterprise had a significant impact on the landscape. The undulations in Fig. 39 are only a few feet from the abandoned channel of the Coldham's Brook (Fig. 38) hidden by the trees.
