The Cherry Hinton Brook

A. Hydrology and over-abstraction

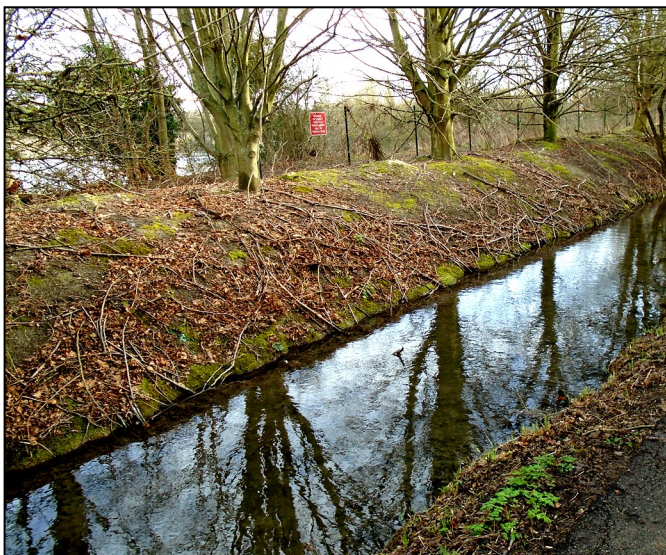
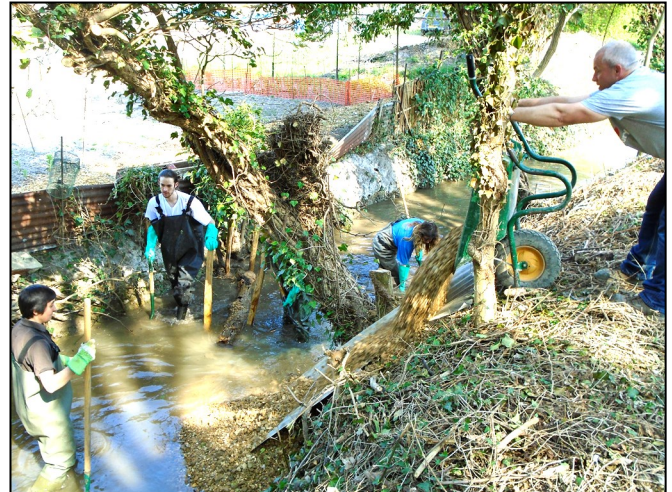
Along with most of the River Cam's tributaries the Cherry Hinton Brook suffered canalisation. This was a process, supposedly to reduce the risk of flooding which fell out of fashion by about the 1980s. The result is illustrated in the photo below which was taken along Snakey Path where the stream skirts the three Cherry Hinton Lakes. Typically, the channel was

straightened and deepened and the sides of the channel were steepened with the result that the channel was widened. So, every last vestige of the original Chalk stream channel was destroyed.

In recent years much effort has been put into 'channel restoration' along Daws Lane (photo above, 2021) and Snakey Path by shovelling in many tons of flint gravel. However it does raise the question, 'What is being restored?' The beds of Chalk stream channels elsewhere in England typically consist of flint gravel but judging by the spoil levée in the photo (below, left) there was no gravel here. Presumably the bed of this

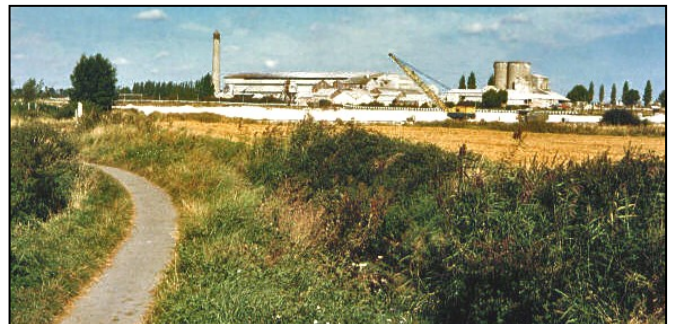
channel was cut directly in the West Melbury Marl which, it so happens, contains no flint to have provided a residual gravel. Anyway, the channel bed is now covered mainly by a thick layer of silt which is totally unsuited to a thriving Chalk water ecosystem.

One of the Lakes is just visible in the photo on the left. These flooded quarries are, in themselves, an abuse of landscape on a heavy industrial scale, having provided clayey Chalk for the adjacent cement works (see photo above) which served the citizenry's demands at the time. The works were demolished in 1988 but are shown in the 1981 photo above taken from near the Daws Lane allotments with the overgrown Brook channel in the foreground. In 1950s, within living memory, waste from the works was discharged into

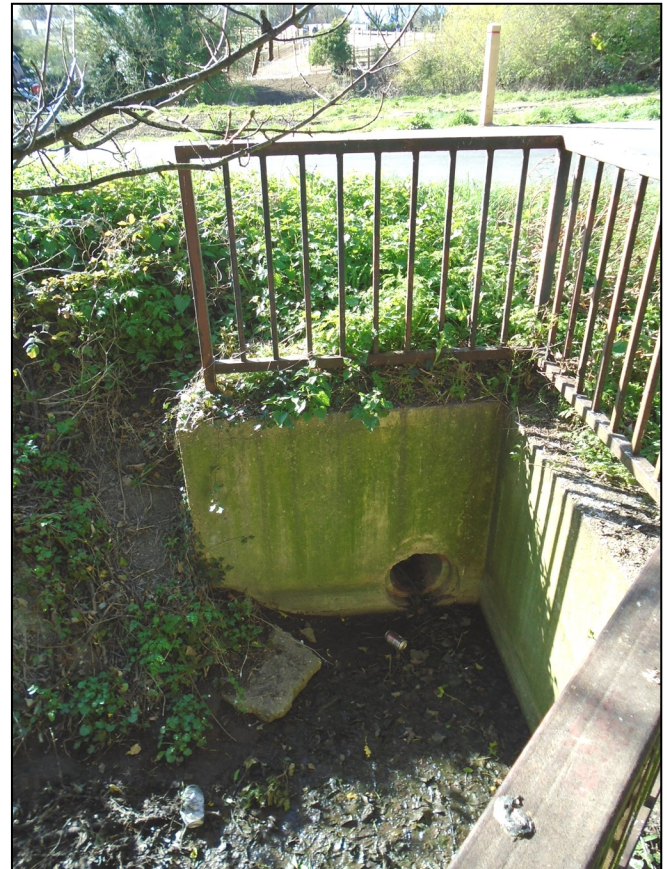
The photo above right shows where, in effect, the Cherry Hinton Brook terminates, nearby at (e).

The channel of Coldhams Brook also therefore ends here, ignominiously, without quite reaching the Newmarket Road. In the 16th century the Brook continued in its alignment, crossed the road and supplied a paper mill (a precursor of CUP) with water. If the flowing water of the Brook should ever reach (e) nowadays it would have to enter the pipe in the photo (shown as dashed line ef on map) and to flow down the slope into the East Main Drain flowing from left to right in the shallow valley near the top of the photo. There is no escape. Coldhams Brook and the Cherry Hinton Brook cannot reach the River Cam undefiled. All of their combined waters enter the East Main Drain sooner or later.
